Pipe Inspection Using the BTX-II

Deactivation and Decommissioning Focus Area

May 1999

Demonstrated at
Fernald Environmental Management Project – Plant 1
Fernald, Ohio

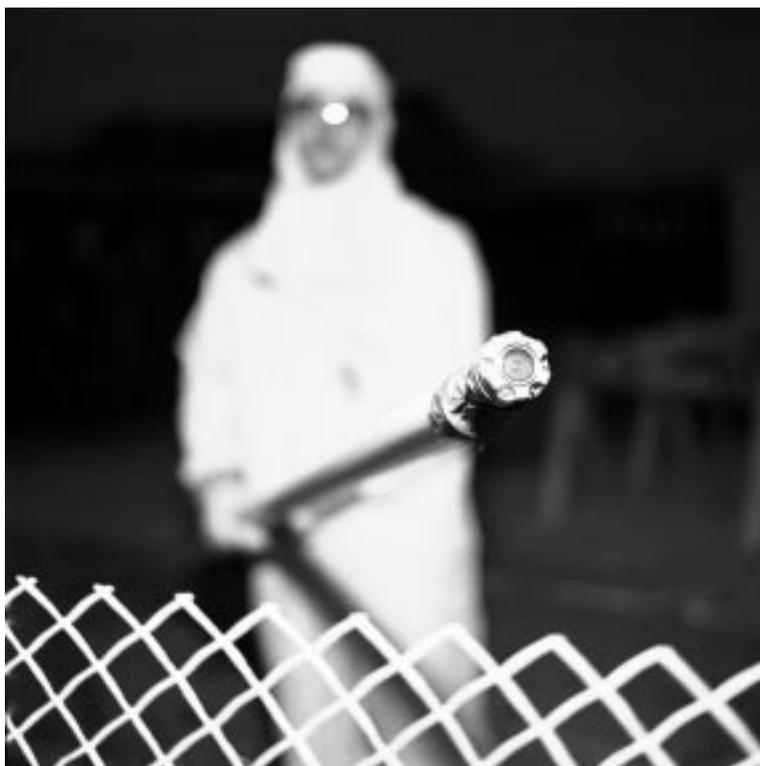
The camera is mounted on the end of a long probe (a piece of PVC pipe during this demonstration) and is inserted into the pipe to be inspected (Figure 1). Workers manually push the probe through the pipe while the operator at the screen looks for the presence of visual contamination (Figure 2). The operator at the screen can give the camera operator directions about the required movements in the pipe in order to properly view the entire interior.

Figure 1. The camera assembly on the end of the inspection probe.

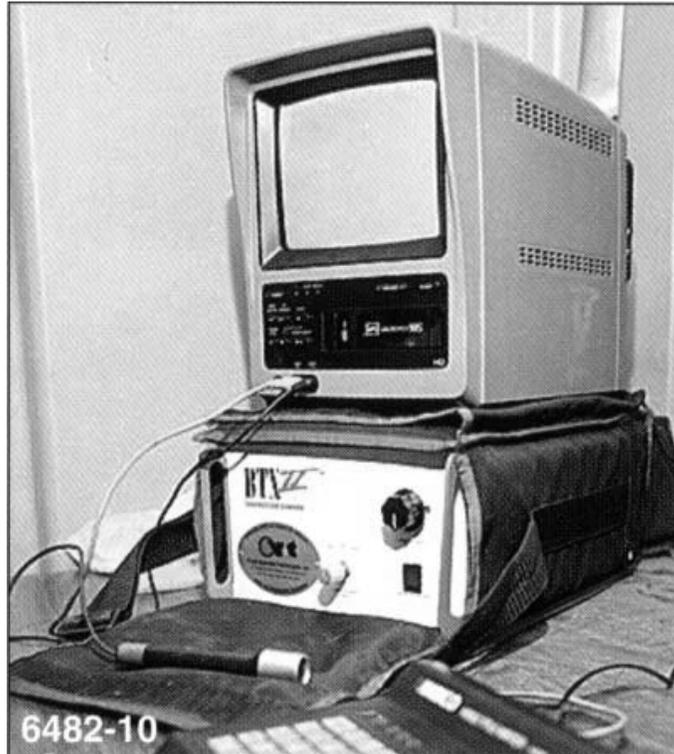
Figure 2. The video monitor and recording unit.

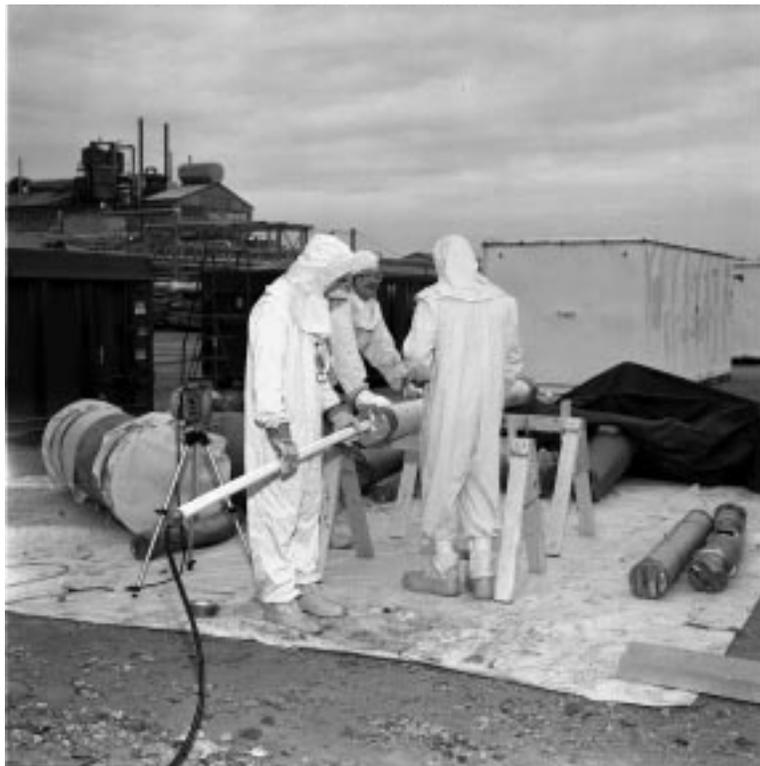
Figure 3. Workers inspecting a pipe with the BTX-II system.

A crew of six workers would typically be used for pipe inspection with the BTX-II. Two workers would move the pieces of pipe into position for the camera and would segregate the pieces based on the inspection results. One worker would operate the camera, and one would operate the video unit. A fork lift operator and a rad tech would also provide support, either part-time or full-time. Figure 3 shows workers inspecting a pipe during the demonstration.

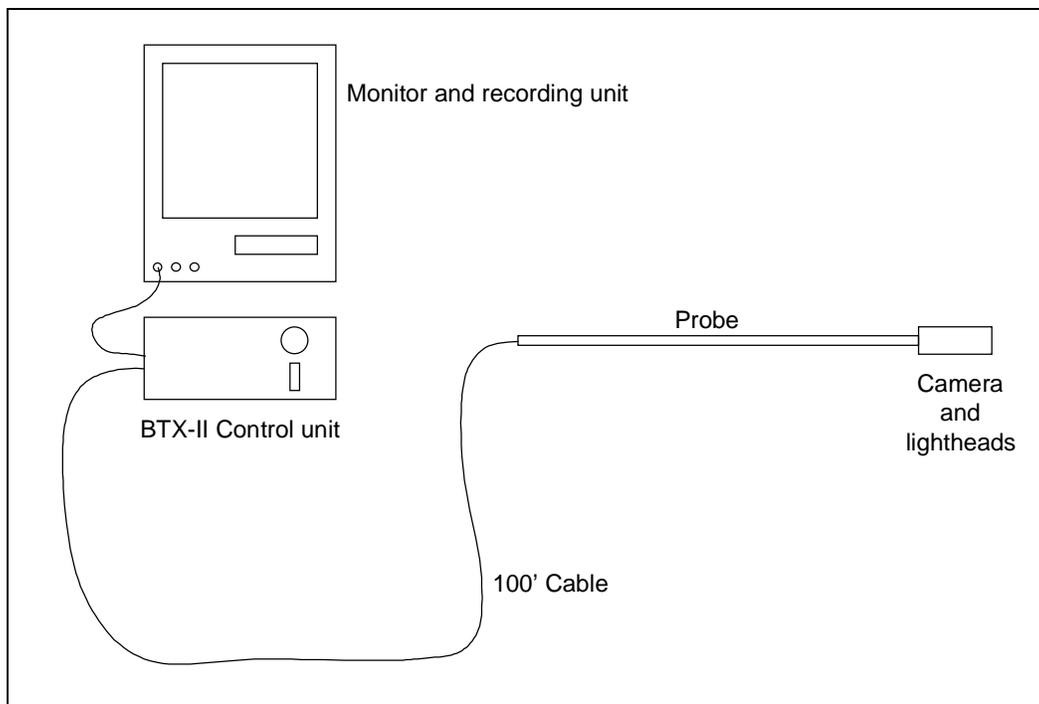
The BTX-II demonstrated at the Fernald Environmental Management Project (FEMP) consists of a high resolution color camera with lightheads, a long probe on which it is mounted, cabling, a video monitor, and recording unit. This technology was investigated as a means of allowing the visual inspection of the inside of process piping to determine if it meets the criteria to be disposed of in the FEMP's OSDF. The current baseline approach for process piping is to not visually inspect it, assume that it does not meet the criteria for the OSDF, and ship it to NTS in Nevada for disposal. This approach, however, significantly increases the cost of disposal. In addition, landfill space at NTS is unnecessarily used up and packaging and transportation costs are added to the disposal costs.

Figure 4. Schematic of the BTX-II system.

Figure 4 illustrates the setup of the BTX-II system.

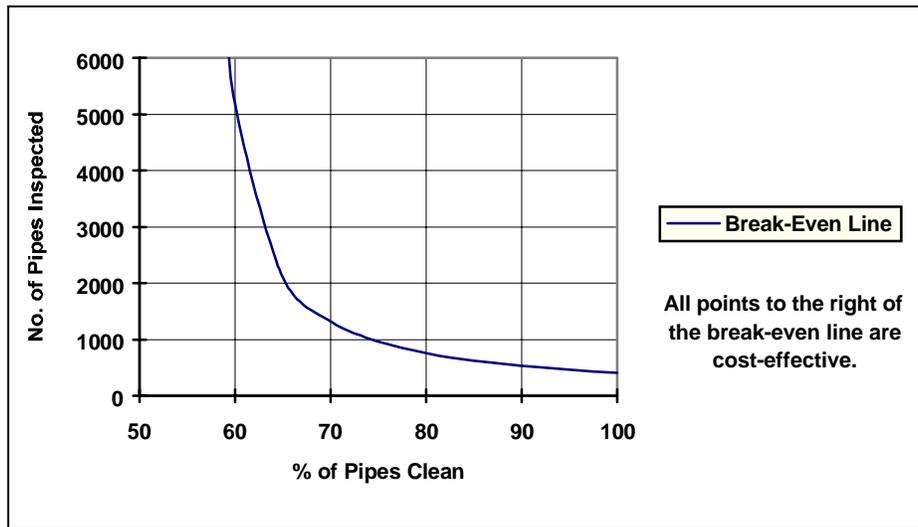
Values were selected for p and the first expression solved for corresponding values of x . The values of p and x were then graphed as shown in Figure 5. The break-even graph is asymptotic at 56.6%. For all points to the right of the break-even line, deployment of the BTX-II System will be cost-effective, and the unit cost savings will recover the fixed deployment costs.

Figure 5. Break-even line analysis.
