From: Waggoner, Larry O
Sent: Thursday, October 20, 2005 12:49 PM
Subject: ALARA Center Activities for Week of October 17, 2005

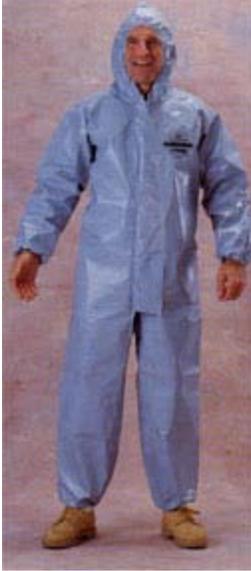
2. The ALARA Center recently received excess personal clothing from West Valley DOE Site. The shipment included 22 pair of light blue TyChem 7500 coveralls that have elastic arms, ankles, and hood.

This chemical clothing has high tensile and burst strength, resistant to hydrocarbons and has been tested against Weapons of Mass Destruction Agents. It is not flame resistant.
