From: Waggoner, Larry O
Sent: Friday, September 15, 2006 1:49 PM
Subject: ALARA Center Activities for Week of September 11, 2006

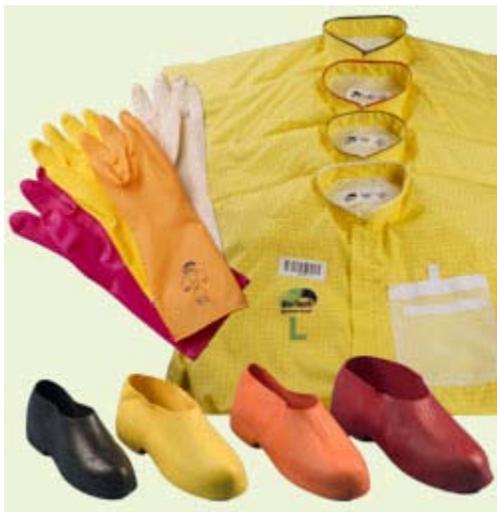
2. Traci Rued, Ground Water RadCon, has some interest in the new PPE overshoes from Unitech, named "Unitrek", at www.unitech.ws. SRS facilities are replacing all overshoes with Unitrek overshoes because each size overshoe has a specific color and is much more flexible (easier for workers to don). The Center has samples if you're interested in comparing to the ones worn now.
