Best Practice Form

Best Practice Title:	Use of Earthen Benches and Other Technologies to Support Remediation and Removal of Contaminated River Structures		
DOE Site:	Hanford Site	Facility Name:	181-N, 181-NE, and 1908-NE Intake and Outfall Structures
Contact Name:	Dan Elkins	Contact Phone:	970-222-9374
Contact Email:	dan.elkins@wch-rcc.com	Interview Date:	February 13, 2013
Interviewed by:	Information provided by reference document listed	Transcribed by:	Heidi Henderson (DOE Fellow, FIU student)

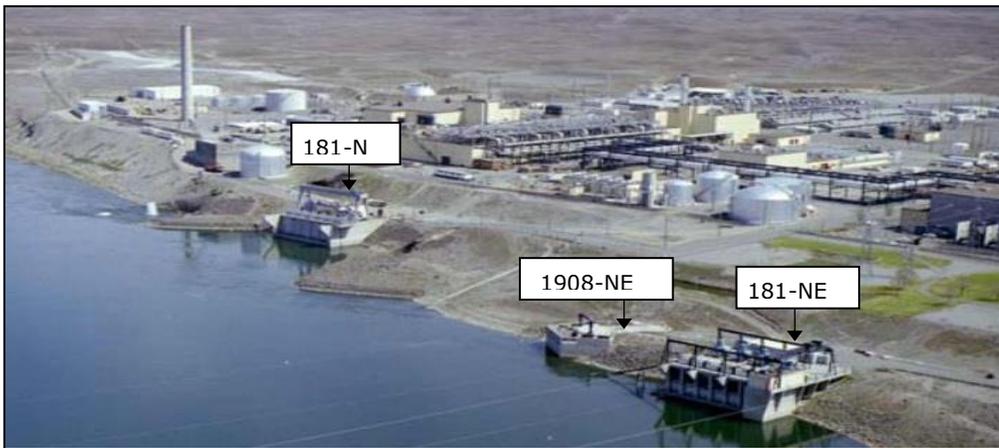
Contaminated Structures along the Columbia River: 181-N and 181-NE Pump Houses, 1908-NE Outfall Structure

The 100-N river structures included two pump houses (181-N and 181-NE) and an outfall structure (1908-NE). The structures were built in the early 1960s to support the N Reactor operations, the world's first dual-purpose reactor, which produced plutonium and provided steam to the Hanford Generating Plant for electricity production. The structures were constructed of steel-reinforced concrete with walls up to 4-ft thick.

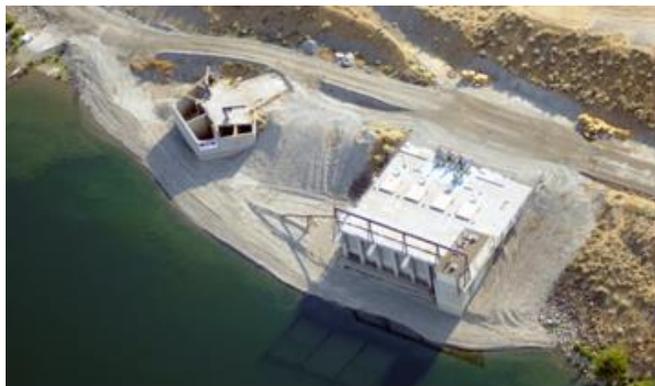
Earthen benches used to isolate structures from the Columbia River

The best practice of using earthen benches was used to isolate the structures from the water of the Columbia River. The benches were constructed to an elevation above the ordinary high-water mark to allow work to continue year round, concurrent with sensitive and regulated aquatic life activities, and alleviated the need to comply with strict turbidity limitation requirements. They provided a stable platform for access to the structure’s pump houses via the sides of the structures and helped attenuate sound during demolition activities. The benches included a core made of borrow material surrounded by a layer of large “rip rap” material to help prevent erosion to the bench. The fill was placed by the edge of the structures in the river and progressively bulldozed into the river (rather than dropped, to minimize turbidity) until a bench and pathway around each structure was created.

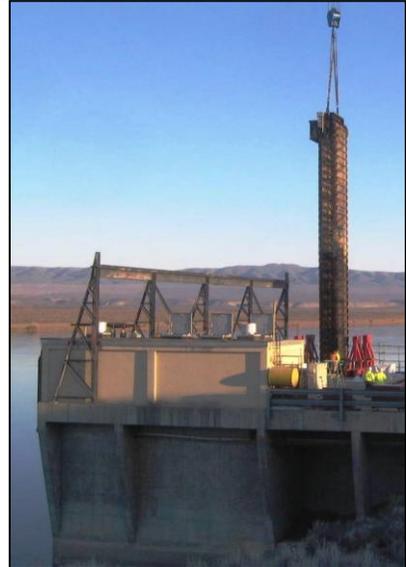
An example of an engineering challenge that was overcome on the project was the removal of 60,000-lb screens that were stuck.

During the 181-NE pre-demolition removal of six traveling screens, each weighing in excess of 60,000 lbs, the 300-ton crane had difficulty breaking the screens free from their locations. As a result, an alternative method was required to safely remove the screens. The project was able to use a hydraulic 1,000-ton picking system, already in use in the 300 Area, consisting of four rams that were placed on each corner of the traveling screen. The hydraulic unit would send fluid slowly to each ram and alternate around the traveling screen slowly lifting each corner. Once broken free, the crane was able to safely pick the screens and lay them down for size reduction and load out. A lesson learned is that any legacy equipment that has not been operated or moved for an extended period of time may require a contingency plan for removal.
