DOE/EM-0587

Remotely Operated Vehicle (ROV) System for Horizontal Tanks

Demonstrated at
Tank T-14
Oak Ridge National Laboratory
Oak Ridge, Tennessee

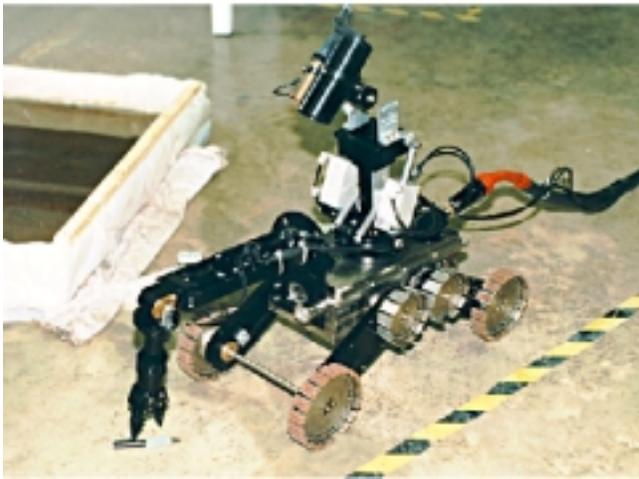
Figure 1. Scarab III vehicle demonstrates dexterity during acceptance testing.

The Scarab III vehicle (Figure 1) is designed to operate either submerged in liquid or in several inches of sludge. The vehicle comes equipped with three cameras: two black-and-white fixed-focus cameras mounted in the front and rear ends of the vehicle's housing and a third color camera with 25X zoom mounted on top of a turret. The articulated drive allows the vehicle to climb over 8-in. obstacles. The vehicle can turn via skid steering within its own length. The vehicle is equipped with a 2 degree-of-freedom (DOF) manipulator arm with gripper.

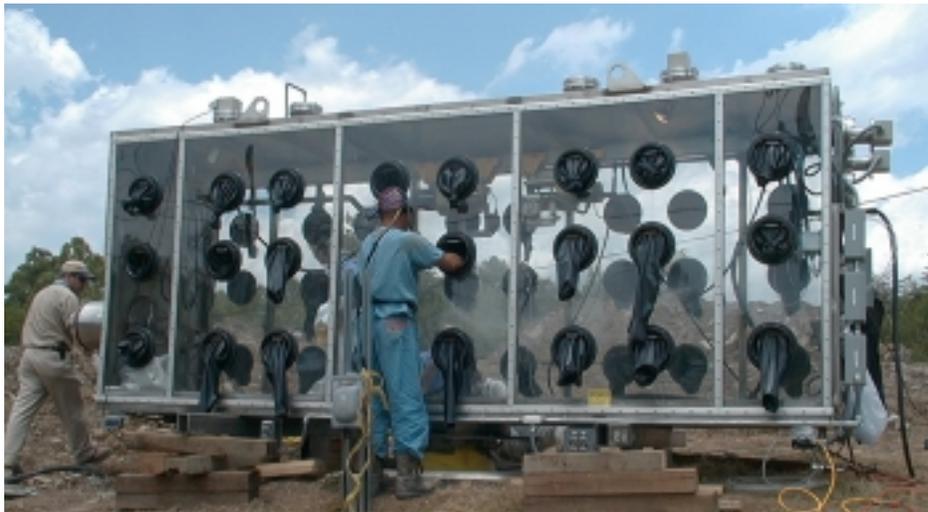
The Scarab III support systems include the DCM and the control consoles. The DCM provides containment and storage for the Scarab III vehicle (Figure 3). This unit includes two winches that are used for deployment of the vehicle and ancillary equipment. An access port in the bottom of the DCM structure provides the interface point between the DCM and the tank to be accessed. A 20-in. bag-in/bag-out port allows removal of contaminated materials or samples, and a transfer chamber with double doors provides easy access for passing in tools and parts. Multiple glove ports on the DCM permit operator interface for maintenance and other supporting activities such as paying out tether as the vehicle is lowered into a tank or composting samples collected. Gross-level decontamination of the Scarab III vehicle is also performed within the DCM with a high-pressure washer.

Figure 3. The containment structure at the Tank T-14 site.

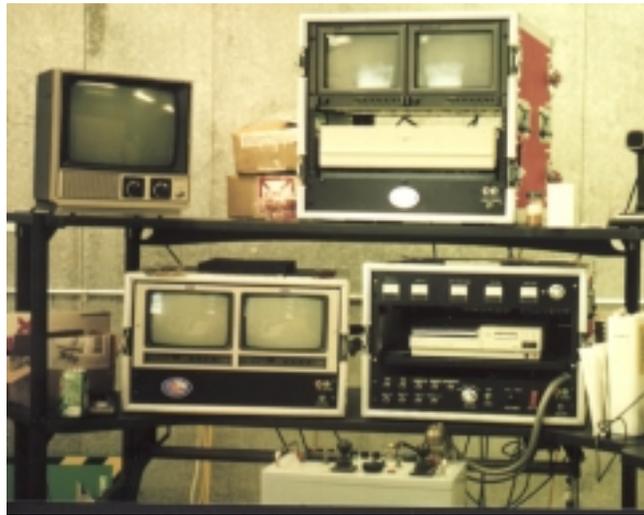
Control consoles for vehicle operation (Figure 4) are lightweight and modular. The Vehicle Operator Control Console (VOCC) houses a joystick for controlling forward, reverse, left, and right turning motions for the vehicle. A second joystick controls rotation of the turret (or top deck) and the turret camera tilt. Other console components are permanently mounted in sturdy shipping crates that can be packed up quickly and easily between field deployments. The Main Control Console (MCC) provides power to the VOCC and is the primary station for transferring video and control signals between the vehicle and other consoles. Manipulator movement, turret camera zoom and focus, and front and rear toe actions are all controlled from this console as well. A color video printer allows snapshots to be collected and printed on the spot. The Monitor Console (MC) displays front and rear camera views from the vehicle. The Record Console (RC) displays turret camera view, but also houses a VCR and monitor to record and display any of the other views available. External camera views (from overview or DCM cameras, for example) can also be captured and recorded.

Figure 4. Scarab III control consoles.

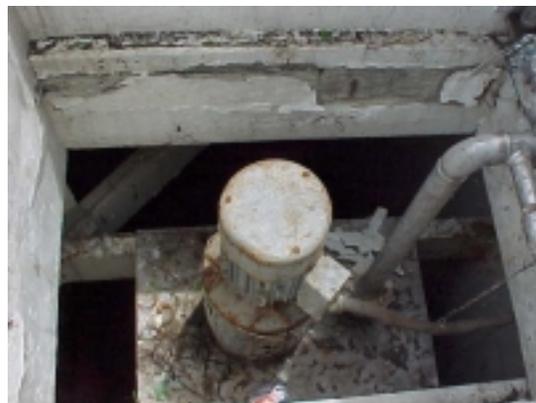
Tank T-14 is an inactive underground tank located under ~1 ft of soil just north of the New Hydrofracture Facility (Building 7860) in the Melton Valley area of ORNL. The tank is a rectangular, reinforced concrete structure with a calculated capacity of ~57,000 gal. The maximum envelope of the tank is ~26 X 29 X 15 ft deep, with a wall thickness of ~1 ft. The tank floor is sloped to a 2 X 4 X 1-ft deep sump. A series of seven precast concrete, span-deck panels comprise the roof of the tank. Access to the tank interior is via a 2.5 by 3-ft hatch located above the sump area (Figure 5). Steel framing to support a sump pump further reduced the accessibility through the hatch.

Figure 5. Tank T-14 Site - access hatch prior to sump pump removal.

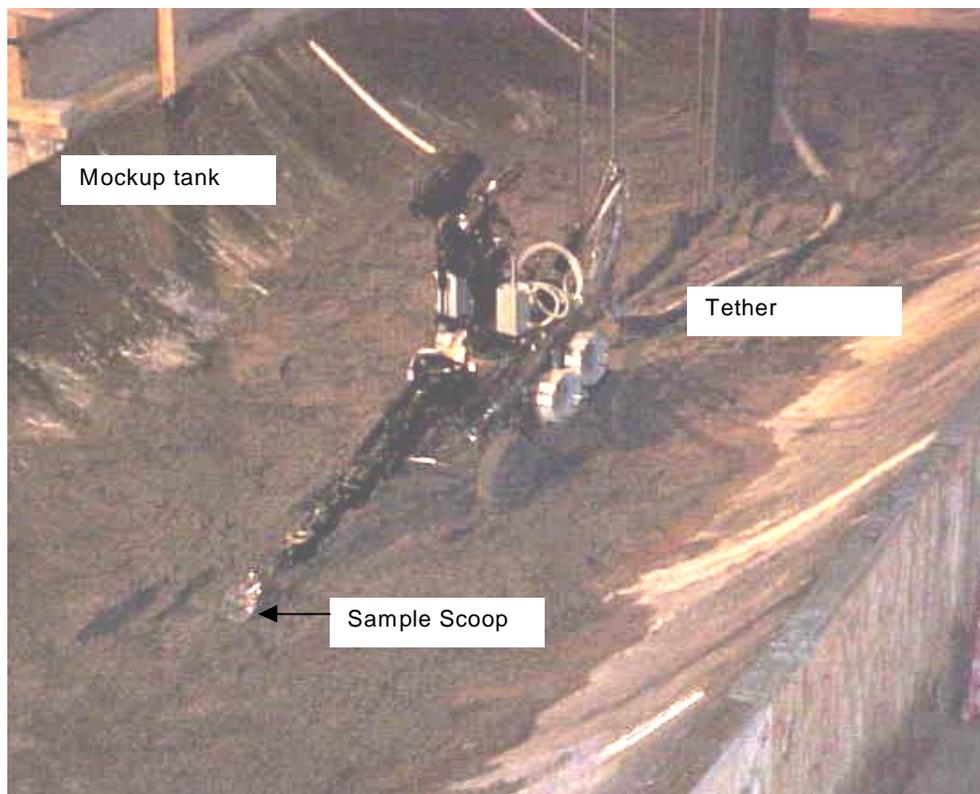
The Scarab III system performed quite well and satisfied successfully all objectives of the Tank T-14 sampling campaign. Observations from cold testing (Figure 8) and in-tank operations indicated that the vehicle could operate effectively in radioactive sludge up to about 8 in. in depth. Operating time for retrieval of the required nine waste samples was 7.6 h. Many of the techniques developed and practiced extensively during cold-testing proved quite valuable during the Tank T-14 sample collection activities and ensured a smooth and successful campaign. These samples will be used to characterize the waste to support tank remediation decisions. Videotape records were created and are available for essentially all in-tank activities.

Figure 8. Scarab III sample collection in mockup tank.
