Summary Report DOE/EM-0483

Frozen Soil Barrier

October 1999

Demonstrated at
Oak Ridge National Laboratory
Oak Ridge, Tennessee

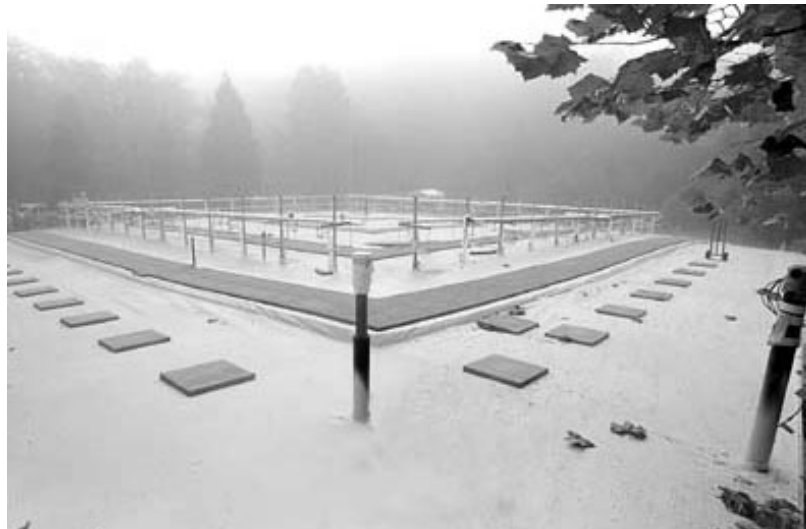
Figure 1. Frozen Soil Barrier system at Oak Ridge National Laboratory

Major elements of the Frozen Soil Barrier system include (Figure 1):

- below-ground **thermoprobes** installed vertically at equal intervals around the perimeter of a known source of contaminants (These devices utilize liquid-to-gas phase change of a passive refrigerant [carbon dioxide] to remove heat from the surrounding soil.);

- above-ground **refrigeration units and interconnecting piping** (Units are standard commercial machines that function to condense carbon dioxide vapor on the interior walls of the thermoprobes.

- **insulation and a waterproof membrane** installed at grade (The insulation prevents heat gain at the ground surface, while the membrane prohibits infiltration of rain water into the isolated zone.);
- a collection of **temperature monitoring instruments and a data collection and storage system** (Soil temperatures are monitored and recorded at several locations and depths in order to monitor system performance.).

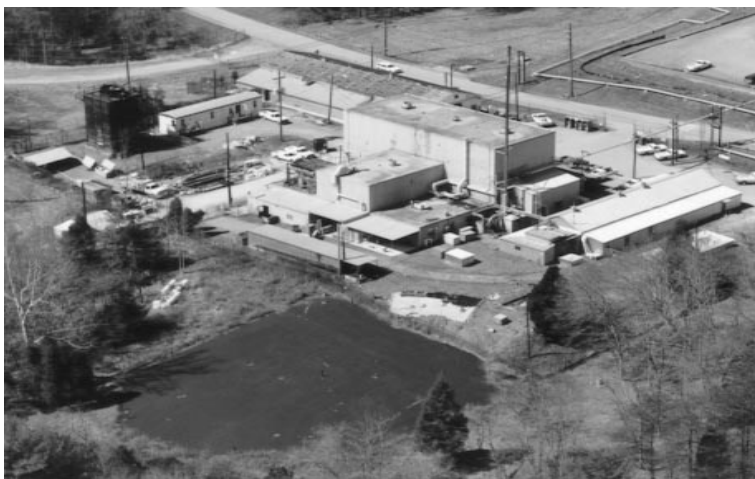
Figure 2. Demonstration area prior to installation of Frozen Soil Barrier. Impoundment is covered by asphalt cap in lower portion of photo

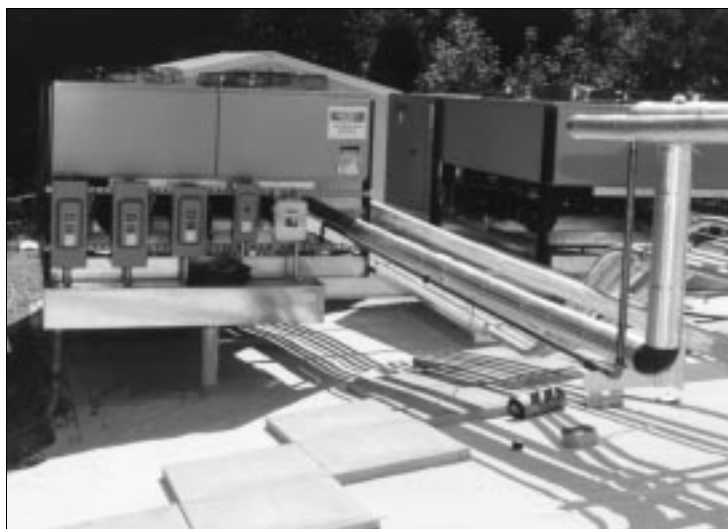
refrigeration units

Figure 5. Above-ground

Above-Ground Refrigeration System – Heat exchanger coils in the top of each thermoprobe are part of the above-ground, or “active,” refrigeration system (Figure 5). A “zero ozone-depleting” refrigerant, R-404a, is circulated to each thermoprobe coil from standard light industrial refrigeration units via above grade copper piping loops. Two separate refrigeration units are utilized, with each unit driving 25 thermoprobes. The two piping loops are configured such that every other thermoprobe in the array is plumbed to the same refrigeration unit.

Thermal expansion valves at each thermoprobe modulate to allow flow of R-404a from the refrigeration units through the heat exchanger coils. Each expansion valve is controlled by a pressurized bulb attached to the suction side of its respective heat exchanger coil, opening whenever the suction side temperature is above –25 degrees F. Each thermoprobe can be isolated from the active system by quarter-turn ball valves.

Each refrigeration unit consists of two motor/compressors in parallel each with two fan coils in parallel. During initial operation, both units were operated simultaneously to rapidly remove heat from the soil surrounding the thermoprobes. Once the Frozen Soil Barrier reached an average thickness of 12 feet, the units were cycled to run for alternating periods of 24 hours each, sufficient to maintain the barrier at design thickness.

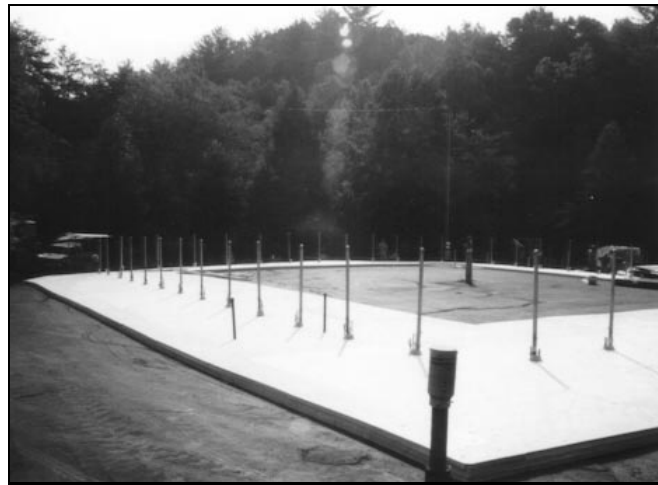
Figure 6. Insulation installed prior to membrane covering

Insulation and Membrane – In order to limit heat transfer to the upper portion of the Frozen Soil Barrier, a 20-foot wide strip of extruded polystyrene, centered along the midline of the barrier, was installed (Figure 6). The insulation was placed in three, two-inch layers for a total thickness of six inches.

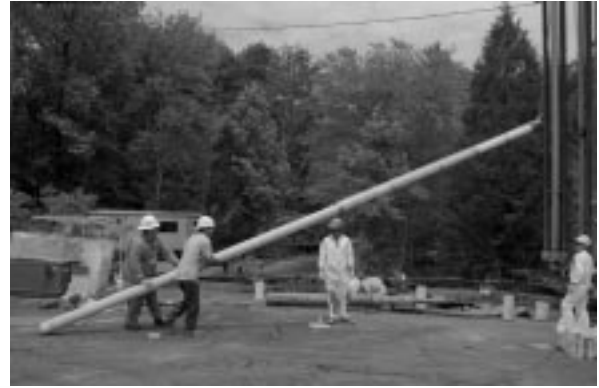
Figure 10. Thermoprobe installation

Boreholes for thermoprobe installation were created by augering to refusal, then switching to air rotary drilling until the required 30 feet (nominal) depth was achieved. Once all thermoprobes and temperature monitoring wells were in place, the above-ground system components were assembled, installed, and tested (Figure 11).

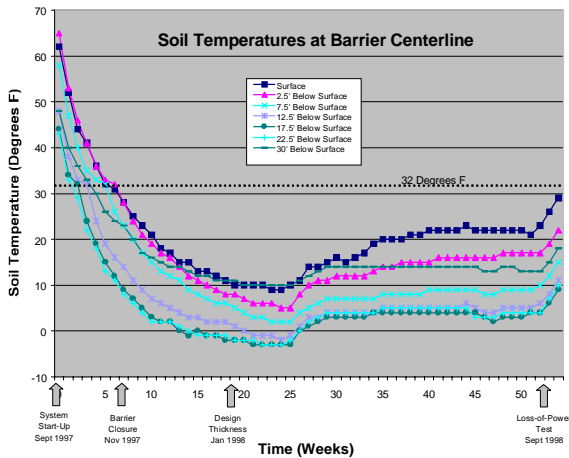
Figure 12. Soil temperatures along

Figure 13. Temperatures six feet barrier centerline (T-2)

Soil freezing was initiated in September 1997, when the two above-ground refrigeration units were powered-up for continuous operation. Data from the monitoring wells were collected daily to monitor subsurface soil temperature changes. In approximately seven weeks of operation, a continuous Frozen Soil Barrier was formed around the perimeter of the impoundment, from the surface to a nominal depth of 30 feet (Figure 12 and 13).

With both refrigeration units operating continuously, soil freezing progressed outward from the barrier centerline. Approximately 18 weeks after initial system start-up, the barrier walls reached their average design thickness of 12 feet. At this point, the full heat removal capability of the dual refrigeration units was no longer required. System operation was modified such that only one unit was operated at a time, driving 25 alternately spaced thermoprobes. This operating procedure has been shown to be effective at maintaining the average barrier thickness at or above design thickness, even through the warm summer months at ORNL.

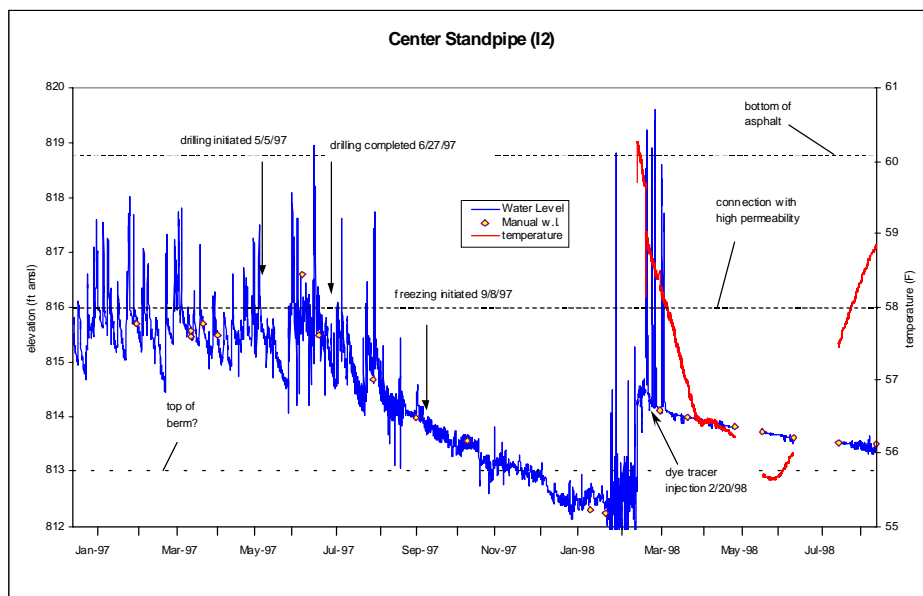
Figure B-1. Hydrograph for Monitoring Point I2.

The jump in water level occurring just before the tracer injections resulted from changeover of the monitoring equipment and installation of a downhole Troll datalogger, which caused a volume displacement within the standpipe. That is not the water level in the impoundment -- it would take some time for the water level in the standpipe to drop because that part of the standpipe is surrounded by low permeability material. Thus, it will follow the same slow decline as before.

The spikes after monitoring equipment change over all correspond to injections of water into the standpipe to flush the tracer. There have been NO responses to precipitation events during any of the time that the Troll has been in place.

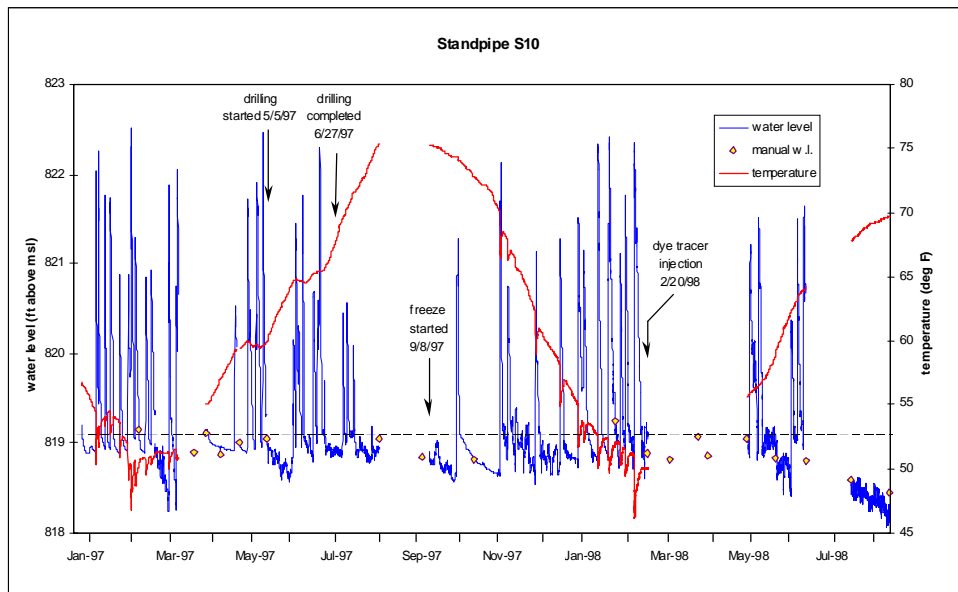
Figure B-2. Hydrograph for Monitoring Point S10

Monitoring Point S10 (Figure B-2): This plot shows the "flashiness" of the storm response characteristic of the entire area surrounding the impoundment. What these data show is the fact that the storm response and seasonal temperature fluctuations upgradient of the pond have not changed during

the period of record. This supports the interpretation of changes in wells downgradient of the barrier as resulting from the barrier and not from any overall change in the region not related to the barrier. S10 may be considered as the upgradient control well.

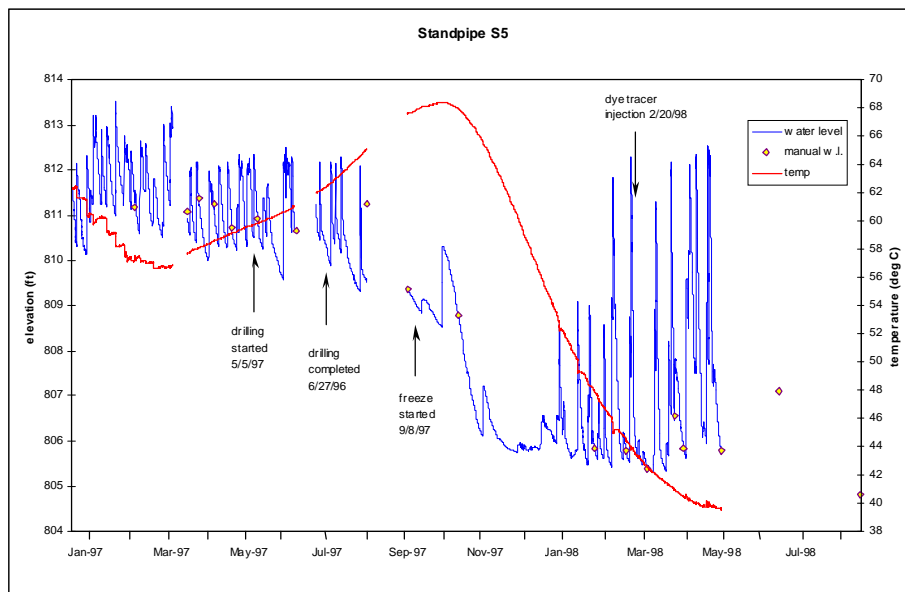
Figure B-3. Hydrograph for Monitoring Point S5

Monitoring Point S5 (Figure B-3): This well represents a downgradient response to emplacement of the barrier. There is an overall drop of around 5 feet, presumably as water is diverted around the barrier. There is also a significant drop in the winter low temperature as compared to the winter before the barrier was in place. The storm response returns after the water level stabilizes to a new average, and is probably caused by water moving rapidly along the original drainage features surrounding the impoundment which would now be subsurface preferential flow pathways.
